ERA09LA062
NOVEMBER 19, 2008
GREEN COVE SPRINGS, FLORIDA

AIRBAG SAFETY STUDY FACTUAL

Airbag Safety Study Factual

Location: Green Cove Springs, FL
Aircraft Type: Cirrus SR20-1881
Accident Date: November 19, 2008
Accident Time: 1240 EST
Accident Number: ERA09LA062
Airbag Equipped: ☒

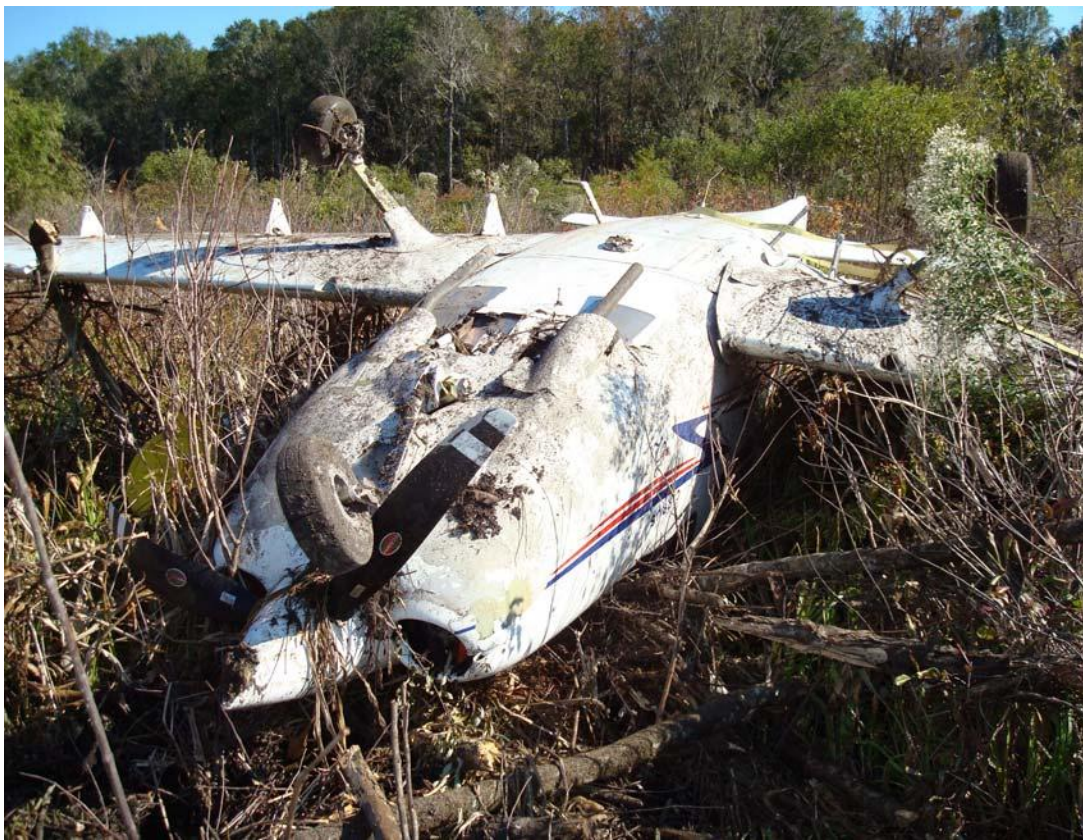
The airplane came to rest in a swamp in an inverted position (figure1). The left wing remained attached to the fuselage and a tree branch impacted the leading edge of the wing at about the midpoint of the wing. The right wing remained attached to the fuselage and was intact except for a small area of fuselage at the rear spar that was cracked. The left and right main gear remained intact and the nose gear remained attached to the nose of the airplane and was bent to the right. The upper weldment for the nose landing gear had fractured midway between the bulkhead and the nose gear. The

Figure 1: The aircraft in its final rest position after the accident.

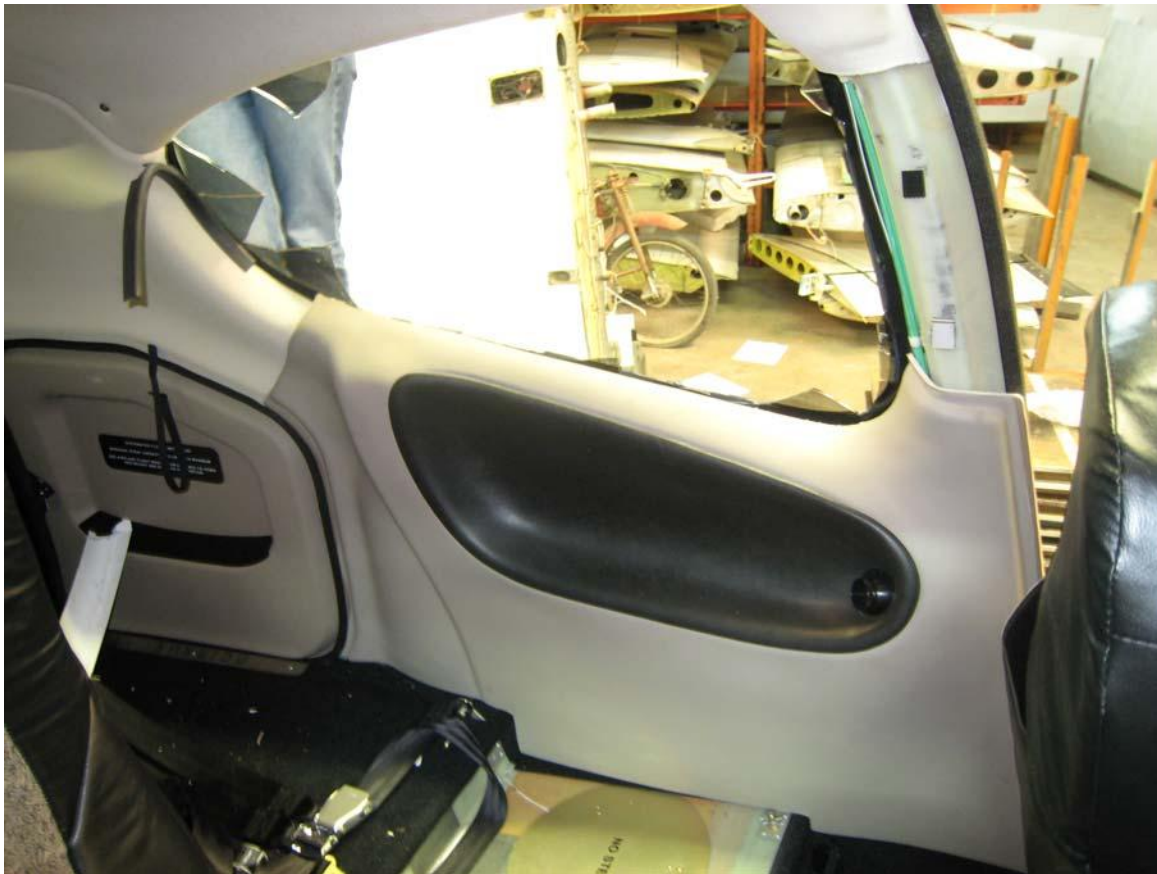
top of the vertical tail fin was scraped and the horizontal stabilizer remained intact. The propeller blades were curled rearward at the tips and the spinner was dented on both sides of the spinner. The left side of the engine cowling was fractured at the forward fuselage attachment. The left cockpit door window was cracked (18 X 8 inches cracked and broken area) and partially broken. The rear left window was entirely broken from the window frame with edges of the window around all edges (figure 2). The rear window was cracked on the left forward area of the window in an area that measured 7 X 10 inches. The aft antenna mounted on the crown of the fuselage was broken and the fuselage was cracked between the aft antenna and the center antenna. The ballistic recovery system (BRS) parachute had separated from its compartment and remained contained in its pouch. The fuselage panel that contains the BRS had separated from the fuselage. (If the airplane is inverted and not in motion and the BRS handle is pulled the BRS will separate but not deploy the chute.)

Figure 2: The left rear window.

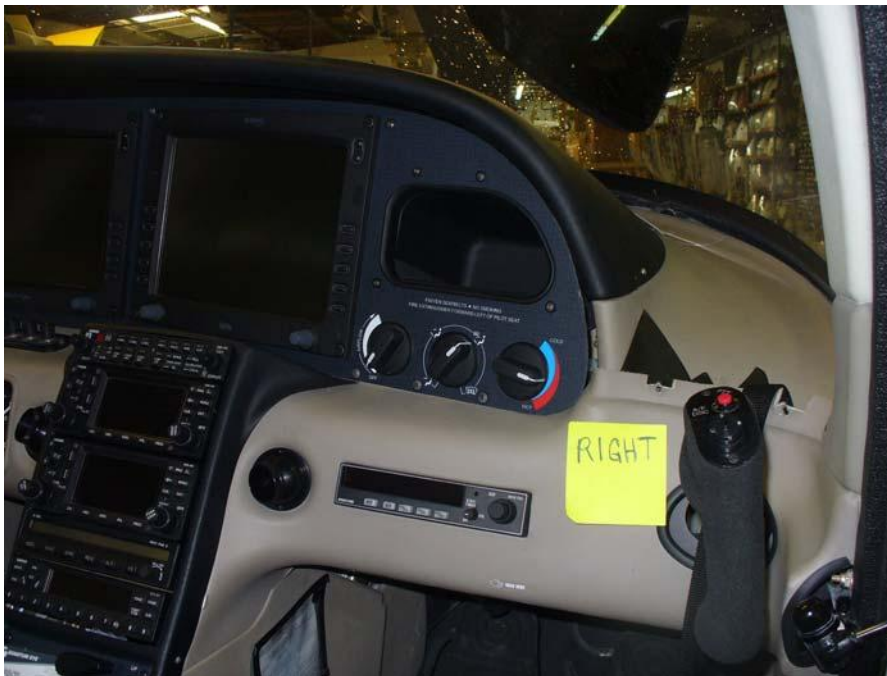
The cockpit, cabin, seats and restraints remained intact except for a small area of the bolster panel in front of the right crew seat had separated at the outboard upper attachments (figure 3). The instrument panel above the right bolster panel had separated at its outboard end. The left visor was fractured at the inboard end of the visor (figure 4). The control columns were intact.

Figure 3: Separated bolster panel

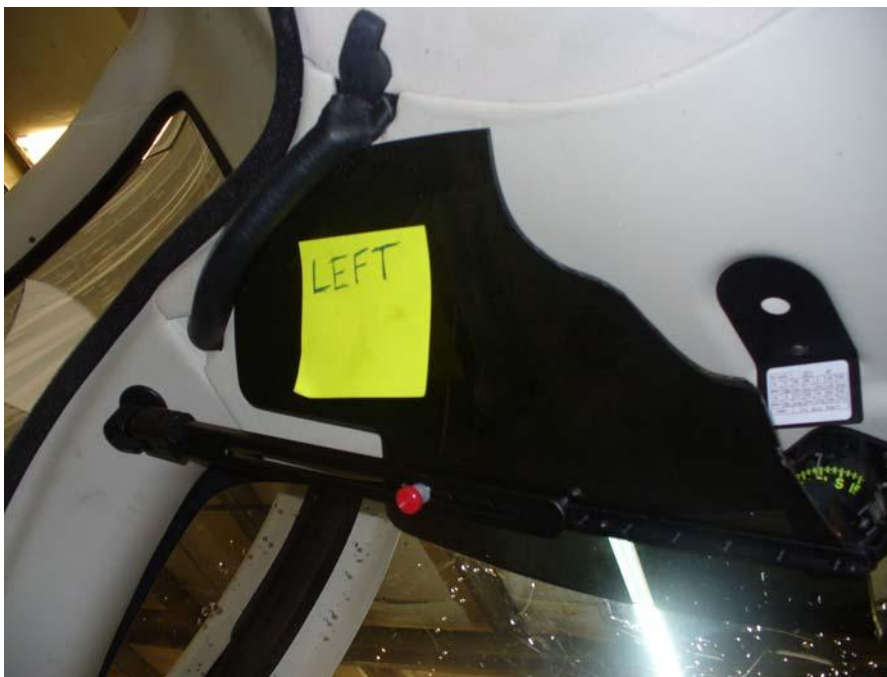
Figure 4: Fractured left seat visor

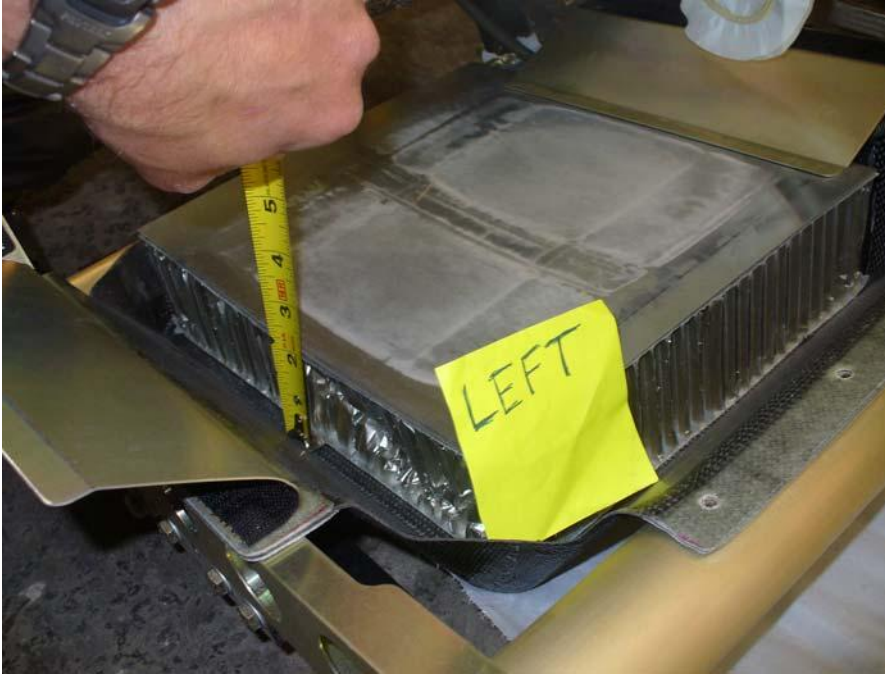
- The left cockpit seat honeycomb energy absorbing core structure was compressed from the forward inboard edge through 4 inches aft of the inboard forward edge (figure 6). The depth at the inboard forward edge was 2.25 inches and gradually compressed to 2.0 inch, 4 inches aft of the forward edge of the honeycomb seat pan (nominal thickness of the honeycomb is 2.5 inches.)
- The right cockpit seat's honeycomb energy absorbing seat structure showed minor compression of the forward outboard corner of the honeycomb pan where the depth measured 2.25 inches.

Figure 6: Energy absorbing module from the left front seat.

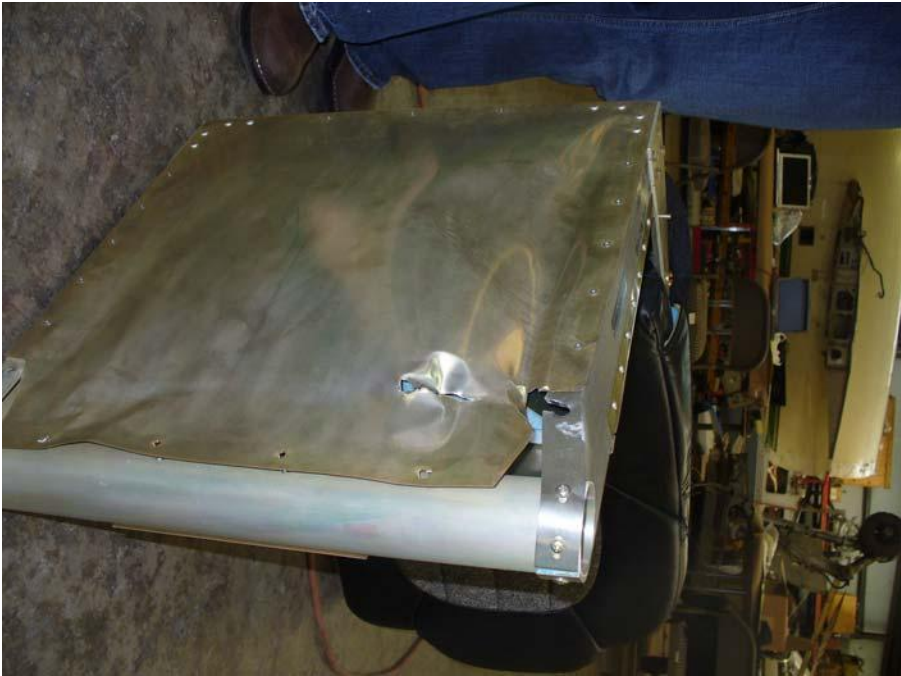
The rear seat was removed from the cabin and it was observed that the forward edge of the lower seat pan had separated from the forward cross tube at the rivets. The outboard forward end of the bottom seat pan was torn and mangled 4.5 inches from the outboard end of the pan (figure 7). The outboard seat frame was dented 4.25 inches from the forward end of the frame.

Figure 7: Tear in right rear seat pan.
